Case Study

Case Studies Show That Return Spectrum Monitoring is Not Enough

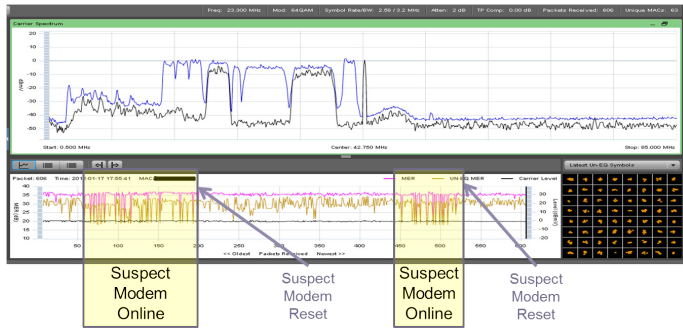
Figure 3. Improvement after resetting the modem

Resetting the modem stabilized the MER until the modem came back online, as Figure 3 shows. Occasionally, the modem would come back on line, but on a different upstream carrier, followed by poor carrier performance. Therefore, it was determined that the modem was negatively affecting whichever carrier it was on.

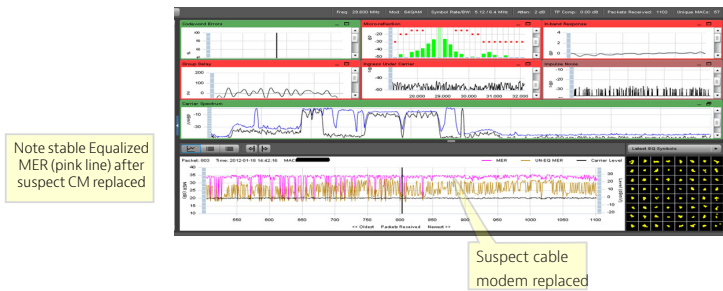
Figure 4. Equalized MER improved after replacing modem

After replacing the problematic modem, the MER stabilized permanently on all of this node's upstream carriers, as shown in Figure 4, and permanently resolved the intermittent service issues affecting other customers on the node. It was determined that the faulty modem transmitting outside its Data Over Cable Service Interface Specification (DOCSIS®) time slot and colliding with other modems transmitting within their time slot was the root cause for the other modem(s) to go offline intermittently. This collision would randomly cause intermittent poor service for several customers on multiple upstream carriers on this node. Using MacTrak performance monitoring and the live QAMTrak analyzer helped the cable company quickly resolve an issue that would have otherwise taken a lot of time and caused a lot of frustration, and it avoided losing customers because of poor service quality.

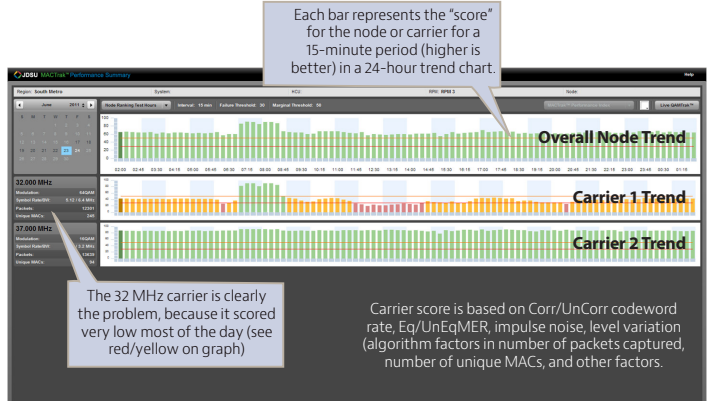
Figure 10. 24-hour node summary shows problem carrier

Clicking on the node gives a 24-hour node summary, as shown in Figure 10.

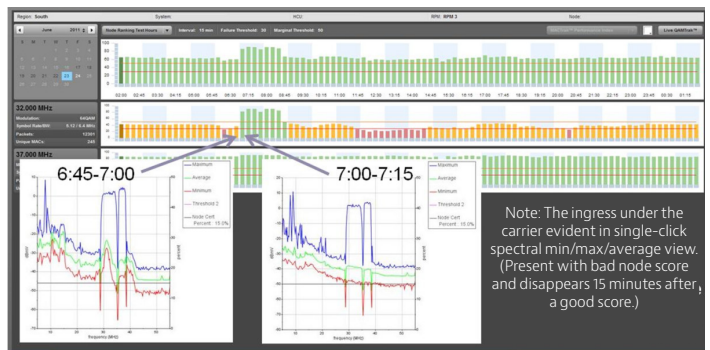
Figure 11. 15-minute spectrum summary display

Clicking one of the bars in the graph will display a spectrum summary for a 15 minute period. The cause of the poor performance is clearly seen in the historical spectral shots during the periods with degraded performance (Figure 11).

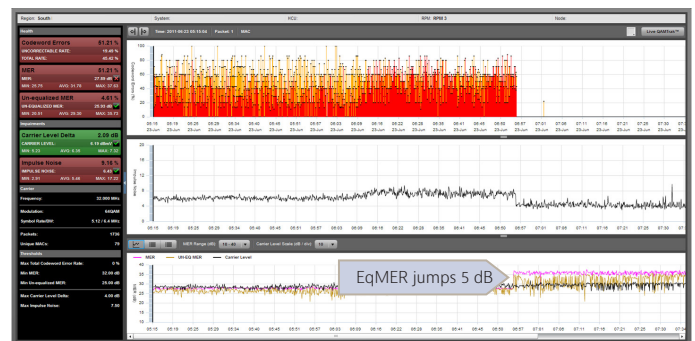
Figure 12. Codeword error cleanup

Double-clicking any bar on the node summary reveals packet-by-packet details shown in Figure 12. Clicking on a transition period from bad performance to good shows a dramatic change in equalized MER and codeword error rates.

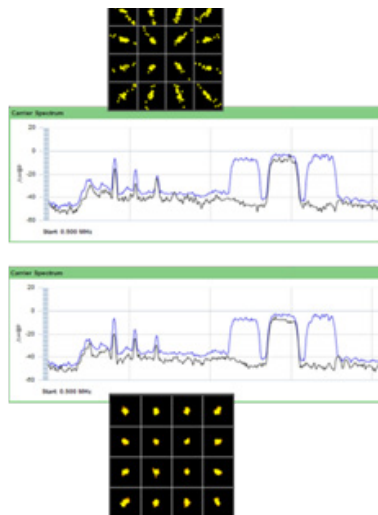
Figure 15. Spectrum vs. Constellation

Comparing the spectrum and constellation displays of good and bad packets, shown in Figure 15, the constellation displays clearly indicate a problem, while

the spectrum displays look virtually identical. However, a relatively clean spectrum above the diplex filter, shown in Figure 16, seems to rule out laser clipping

Furthermore, checking optical power levels showed they were within specification. The problem was traced to a faulty optical receiver. Redundant optical receivers in the headend contributed to the intermittent codeword errors when switching between primary and secondary receivers.

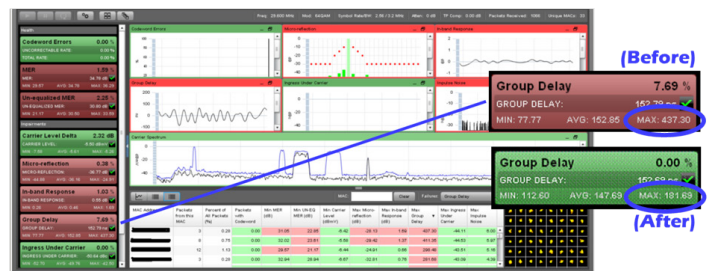
Figure 17. Group delay improvement

Customers on a node intermittently experienced slow modem speeds and connectivity. Plant-related issues could not be identified. The upstream spectrum in PathTrak showed no ingress or other visible distortions, and node utilization was good. A QAMTrak session indicated that several modems had high group delay, micro reflection, and in-band response issues, as shown in Figure 17. The worst offenders identified by MACTrak were correlated with street addresses and plotted on a plant map to find a common point. This analysis helped discover a defective amplifier which was replaced, resulting in overall improved performance and eliminated the intermittent issues.
